McGill Restoration Demonstrates Artistry with Historic Preservation

530 W. Broadway is a historic brick building in the heart of Council Bluffs, IA. Lund-Ross Constructors was the primary renovation contractor and they put the historic preservation masonry scope to bid. McGill Restoration had worked as a subcontractor with the primary on numerous projects and the bid was accepted.

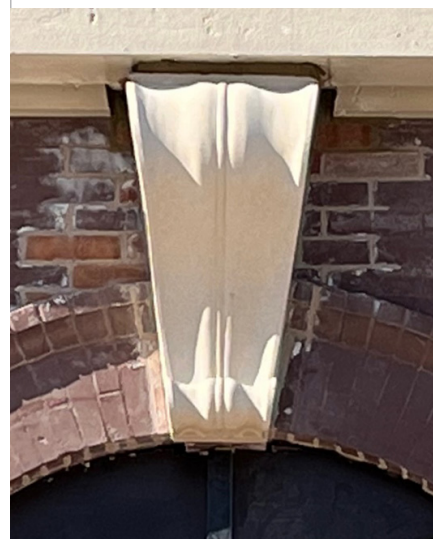
Further, the old brick installed over windows had unique curvatures where even salvaged bricks would not suffice as replacements. The team would need to find a solution that matched the shape and style of brick over each window segment. Without matching bricks available, a mold system was necessary.

Unfortunately, the salvage bricks would not fit curved sections over windows and sourcing matches was a tall and bleak order. Rather than looking for a needle in a haystack, McGill Restoration cast molds of the original brick used and manufactured replacements with the exact sizing required. Matching coloration created the right look and each window segment received was restored to the original shape and style.

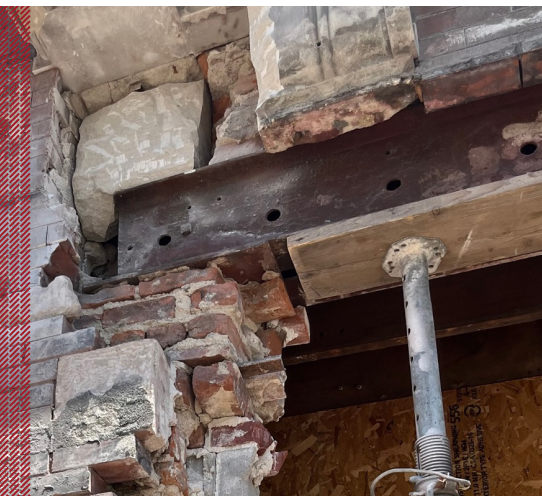
Although the scope is simple on paper, the actual processes were tedious, calling for the highest levels of expertise in masonry and historic building preservation. The team came together, working through each segment of the building on a brick-by-brick basis to recreate the original feel of the structure.

Oversized bricks were sourced from a historic brick salvage in Iowa. They matched the 8 ¼" size and fit the time period with look-alike coloration. With bricks sourced, the masonry crew was ready to grind out and replace mortar while fitting the bricks in corbels and keystone pieces.

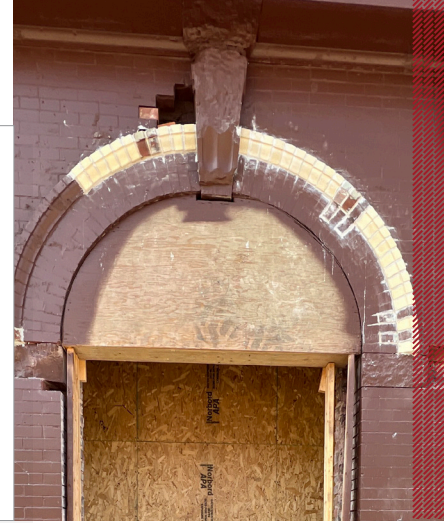
Corbels and keystone pieces presented the greatest challenges in terms of design replication. Armed with historic photographs, the masonry crew studied each element and manifested an artistic approach to restore the original designs.

Experience and the ability to think out of the box were the real keys to restoring these elements. While engineering and the original build determined material choice, the masons were really left to get in the right mindset and use their collective experience to set bricks and match the photographed designs.

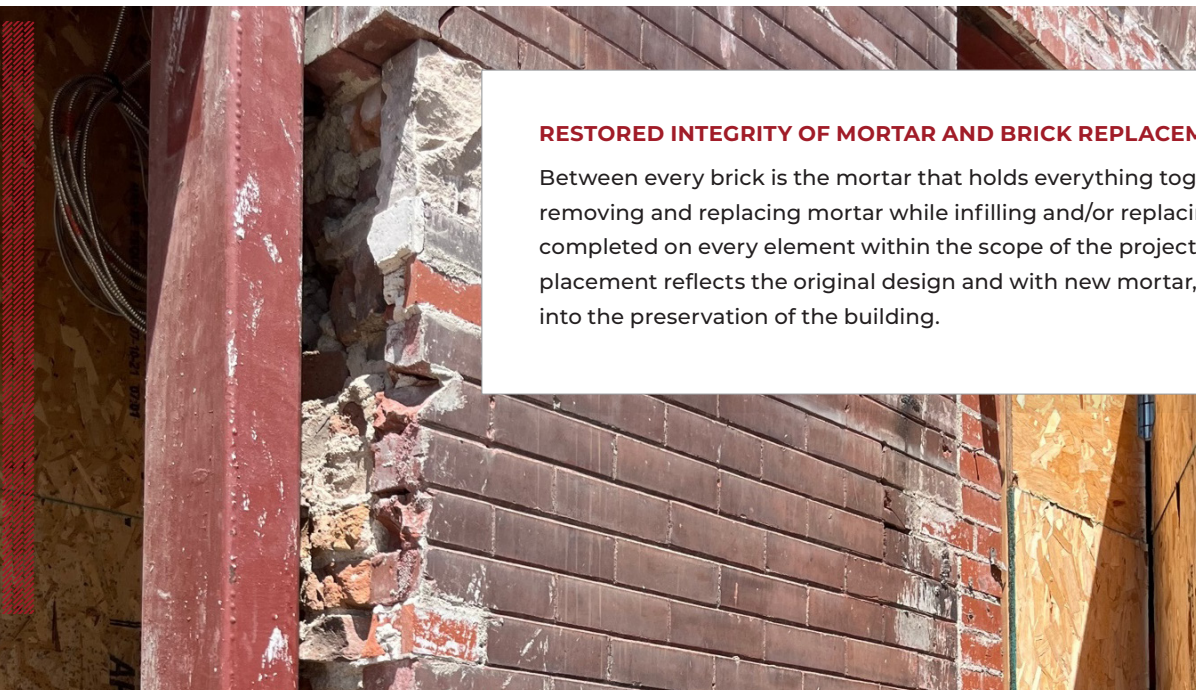
Between every brick is the mortar that holds everything together. Carefully removing and replacing mortar while infilling and/or replacing brick was completed on every element within the scope of the project. Careful brick placement reflects the original design and with new mortar, durability is built into the preservation of the building.

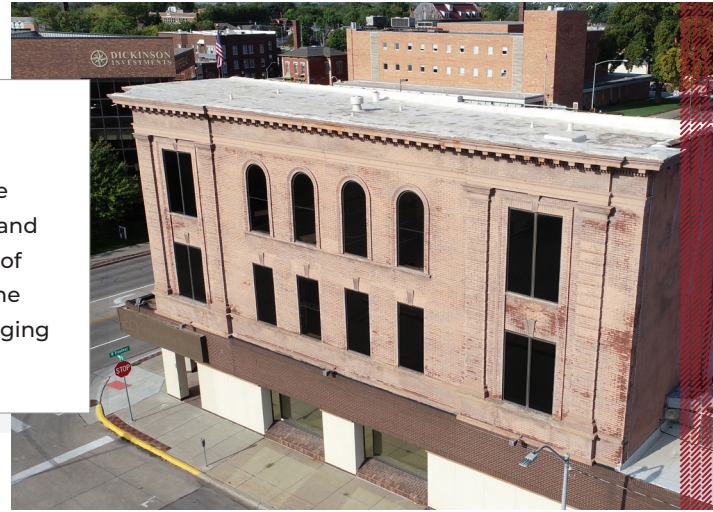
Historic preservation is meant to have an aesthetic that matches the original construction. In this project, sourcing the correct materials and manufacturing custom bricks returned the deteriorating segments of brick to the original aesthetic. With brick renewal and restoration, the building is ready for new retail and residential tenants without changing the traditional feel of the structure.
