Two Parking Structures Restored at Bryan Medical Center in Lincoln, NE

McGill Restoration completed phase one of the Bryan Medical Center project by restoring two of their four parking structures. Connector repairs and replacements dominated the scope of the work. General concrete repair, floor restoration and joint sealants were also completed to restore the structures so they can enter a preventative maintenance program for longevity.

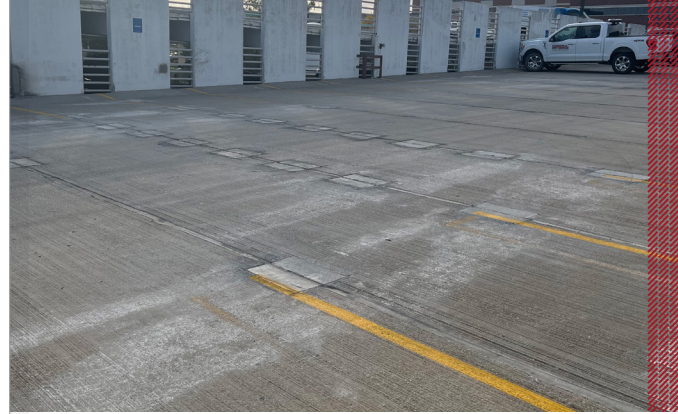
The scope of work on this restoration project included the replacement of all top-deck joint sealants and hundreds of double-T flange connectors. Structural and nonstructural repairs to high-traffic areas were also needed across both garage structures. The nature of the project required acute attention to detail to mitigate vulnerabilities from water entry and general wear and tear.

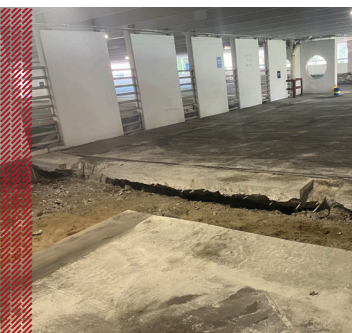
ZONE A GARAGE:

The Zone A garage required a heavy focus on the main entry and the northwest corner of the top floor. Joint sealants were replaced in the main entry, and connectors were repaired to accommodate high traffic. While the work was focused on these two areas, McGill Restoration consolidated into this space, which allowed for another contractor to take advantage of the closed structure to complete a separate job. This win-win strategy provided additional timeline efficiencies and cost savings.

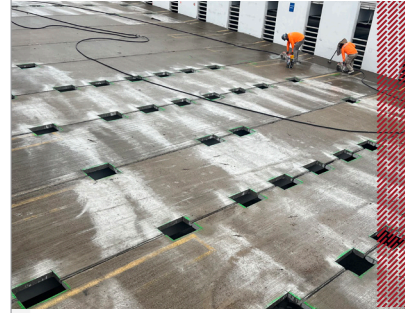
The Zone B garage required major top deck restoration work. McGill Restoration removed and replaced all joint sealants (more than 8000LF), and replaced over 200 double tee flange connectors. Efficient use of crew and resources was accomplished by working on the interior structural elements and exterior nonstructural restoration simultaneously.
