# Cheerio Apartments deteriorating balcony restored within 30-days

McGill Restoration replaced rusted balcony supports and eroding concrete while also discovering and subsequently repairing damaged structural steel in the open stairwell at Cheerio Apartments in Lincoln, Nebraska. The project was bid within budget and completed in less than one month with minimal tenant displacement.

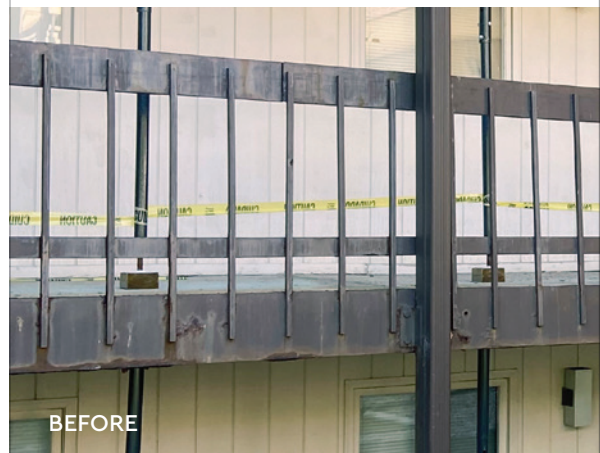
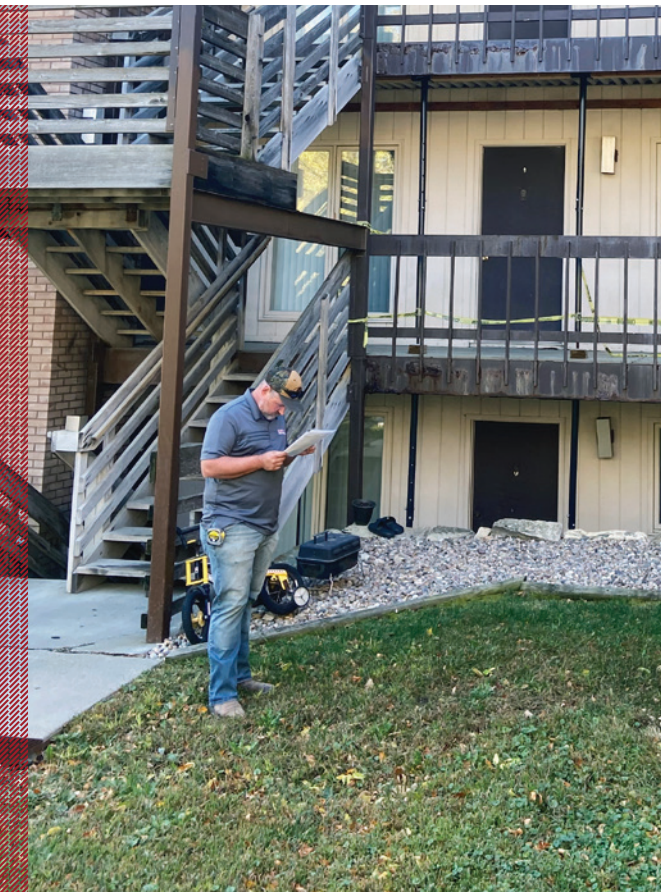
The Cheerio Apartment Complex is a 36 unit, multi-level property in Lincoln, NE. The property management team noticed advanced rusting and deterioration in the galvanized mild steel balcony pans. The level of degradation reached a point where concrete was visible through rusted steel.

- ⊗ Rusted steel reducing integrity of balcony structures
- ⊗ Exposed concrete vulnerable to degradation
- ⊗ Poor aesthetic of deteriorated materials
- ⊗ Tenant safety on balcony structures
- ⊗ Rehoming tenants during construction

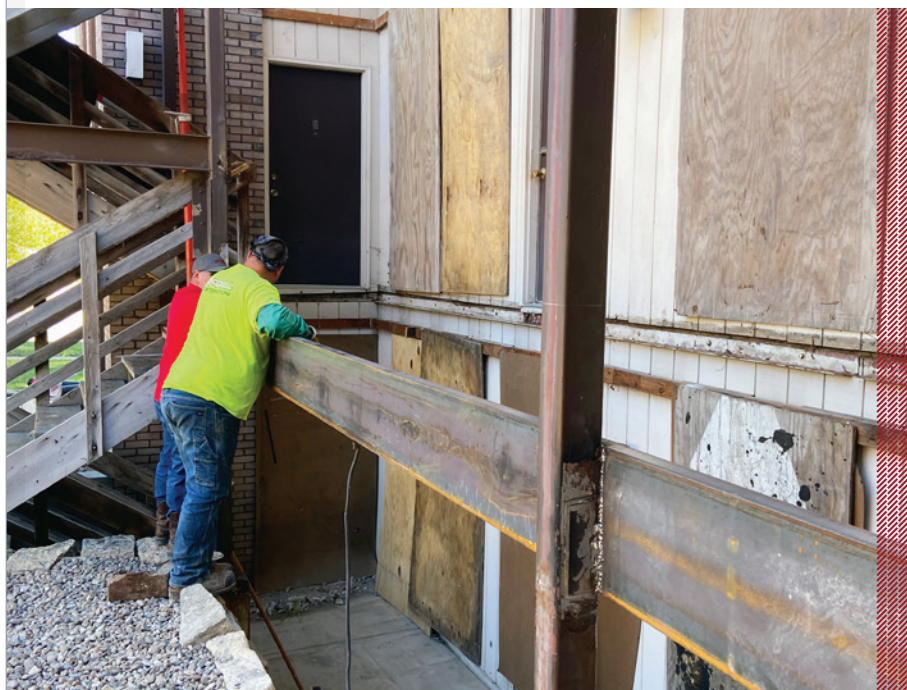
McGill Restoration utilized the 6-month lead time to manage permitting and planning. When unforeseen damage was discovered, their long standing relationships with the City of Lincoln and the PE expedited site evaluations, inspections and recommendations to drive the project forward without interruptions. The ability to move quickly allowed the project to run smoothly and complete all work within the 30-day timeframe.

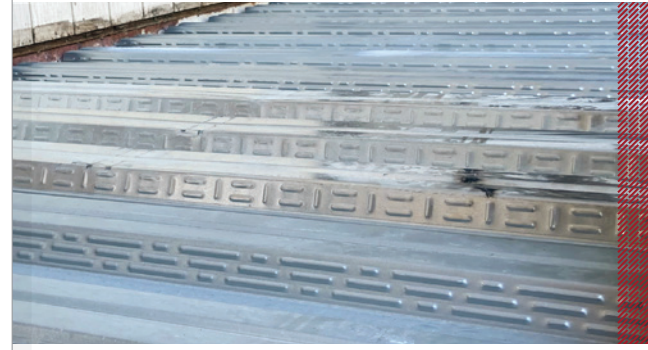
McGill Restoration saved an exceptional amount of time by self performing all site welding with their in-house certified welder. This eliminated the need for subcontractors along with associated wait times in a high demand market. The steel structures were completely welded and built by the McGill Restoration team.

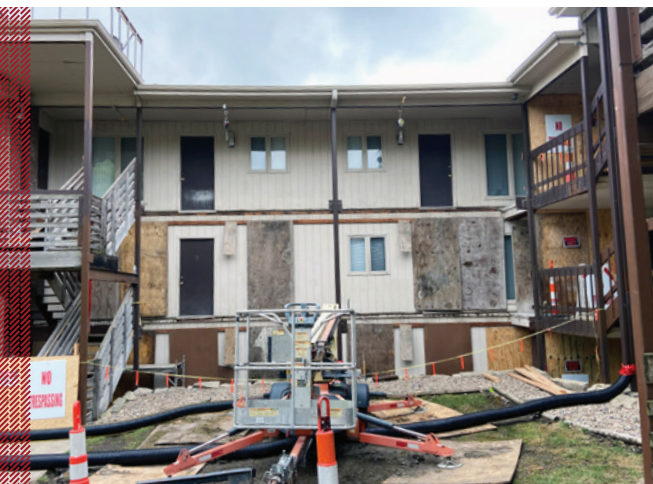
Before McGill Restoration could reconstruct balcony structures and pour new concrete, they removed the deteriorating steel balcony structures. After the demolition was completed, the equipment remained in position for a seamless transfer to the construction phase.

- ✓ Positioning equipment and prepping site
- ✓ Covering windows with plywood
- ✓ Establishing a safe work zone with fall safety for crew members
- ✓ Cutting old steel to remove two levels of balcony structures without damaging upright structural support steel, doors, windows or the building.

- ✓ Transport and manipulation of prefabricated steel components.
- ✓ Site installation, welding and construction of new balcony structure
- ✓ Inspection against moisture and elemental damage for longevity

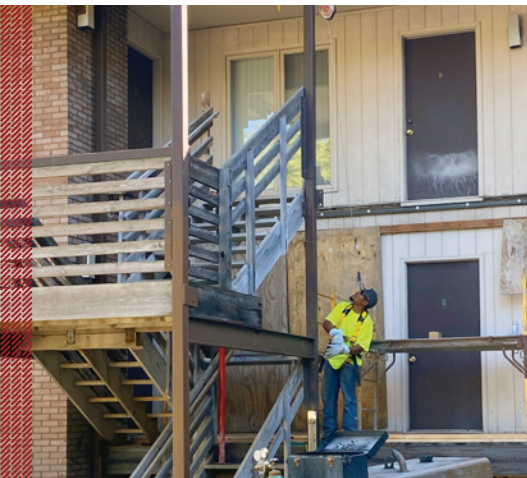
During the demolition process, McGill Restoration discovered significant unidentified corrosion of the structural support steel from water pooling in channel grooves. The damage was covered and unrecognizable until the demolition exposed the affected area. Site work stopped while McGill Restoration quickly incorporated the PE to design and quote additional repairs.

- ✓ Expedite inspection and design solutions by the engineer
- ✓ Add and approve change order to repair the damage
- ✓ Source materials and incorporate repairs into current project
- ✓ Complete additional repairs within the original 30-day timeframe

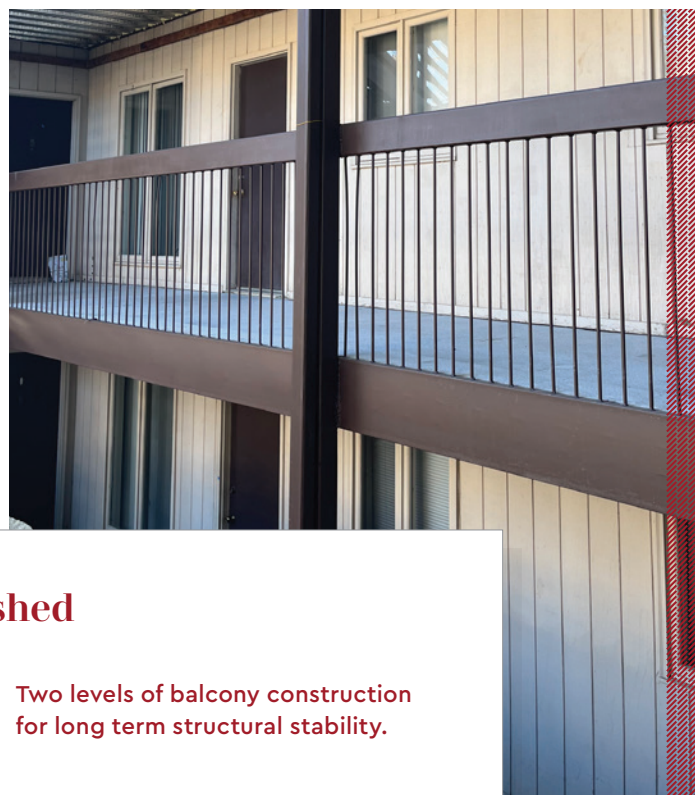
McGill Restoration's expert team was able to complete the site work within 30-days despite the 7 day work stoppage, add-on repairs and time needed to engineer a new solution. Cheerio Apartments property management team minimized tenant relocation times, saving expense while delivering a timely new balcony to increase safety and overall tenant satisfaction.
