Harney Street Garage preserved with major structural repairs and restoration

McGill Restoration returned structural integrity to the Harney Street Garage by making significant structural repairs to the columns and beams of the garage. The project required work through adverse winter conditions while protecting backup generators for a local data center on the upper level. The project was successfully completed in three months at budget.

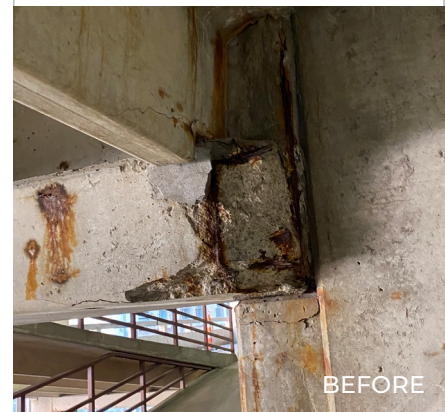
THE BIGGEST ISSUES WERE:

- ⊗ Failed joint sealants
- ⊗ Water damage throughout structure
- ⊗ Crumbling masonry
- ⊗ Scaling surface
- ⊗ Compromised columns and beams

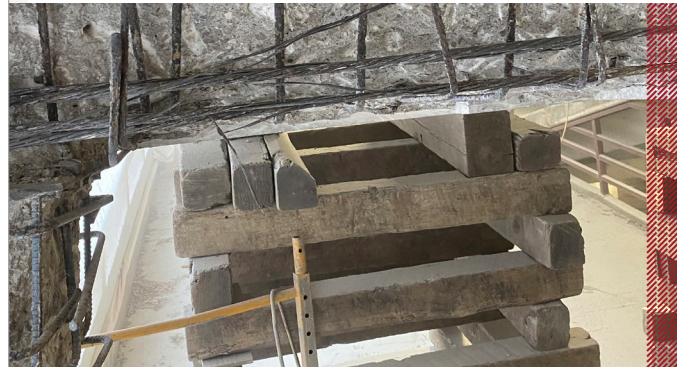
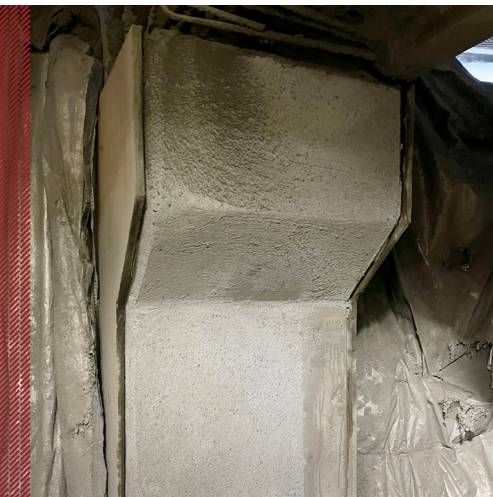
INSTALL CRIBBING AND TEMPORARY RAMPS

McGill Restoration faced a challenge with the top level data center generators adding weight to structural supports. Crumbling columns and beams required immediate attention so the team imported several truckloads of timbers and supports. They removed weight from the existing structural supports and transferred the load to temporary timbers.

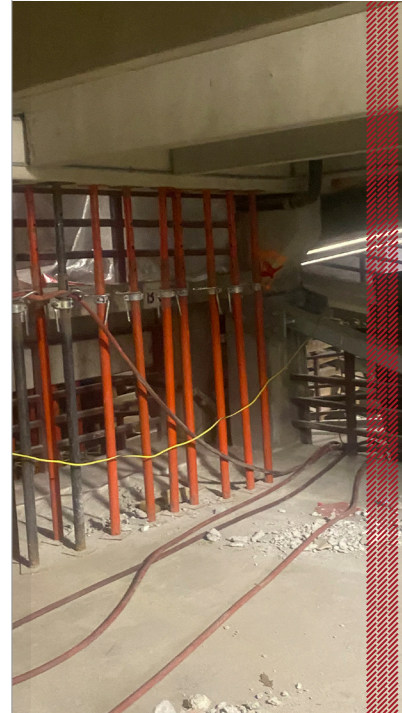
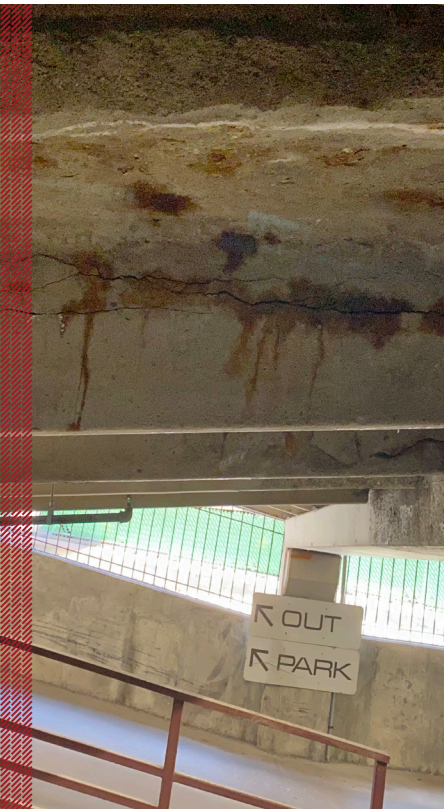
MAINTAIN CRIBBING THROUGH LONG CONCRETE CURING PROCESS

While working through column repairs, McGill Restoration discovered additional damage that was concealed from surface-level inspections. The water seepage from failed joint sealants had persisted for years, penetrating the structure deeply. To properly restore the vertical and horizontal concrete, a more intensive process using a different concrete mix was required and the team adjusted their plan to ensure the optimal outcome was achieved.

Pouring new concrete requires curing times to increase the material integrity and load-bearing capabilities. While the new concrete cured for up to several weeks, the cribbing was maintained to continue supporting each level. Once cured, the cribbing was slowly removed, returning weight to the new load-bearing structures.

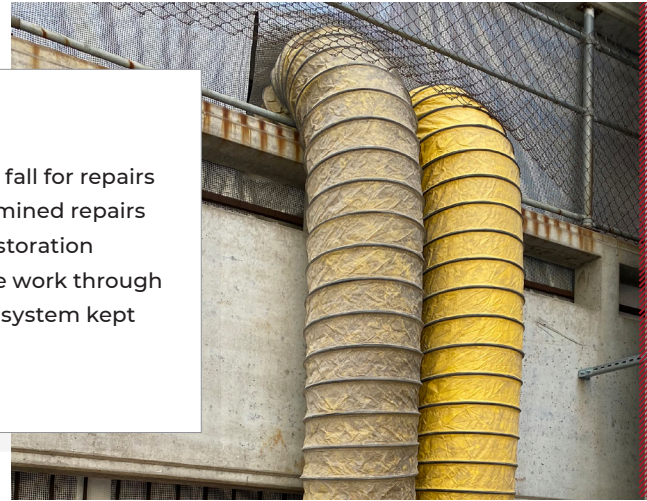
WINTER SITE WORK PREP

Most parking garage projects are completed during summer and fall for repairs and restoration work. The Harney Street Garage ownership determined repairs were imperative and moved forward during the winter. McGill Restoration wrapped the garage and utilized several large heaters to continue work through all outdoor temperatures and conditions. The wrapping and heat system kept the project on track, eliminating weather delays.
