McGill Restoration Systematically Approaches Joint Replacement on Tower

The U.S. Bank Tower is among the tallest buildings in downtown Lincoln, NE, and as such is a community landmark. Constant leaking created disruptions to tenants, ultimately forming a costly patchwork of temporary repairs. The building required a thorough approach to sealing joints with minimal tenant disturbance.

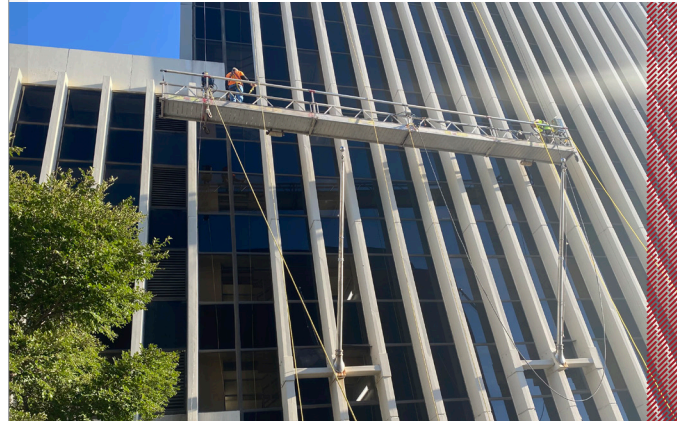
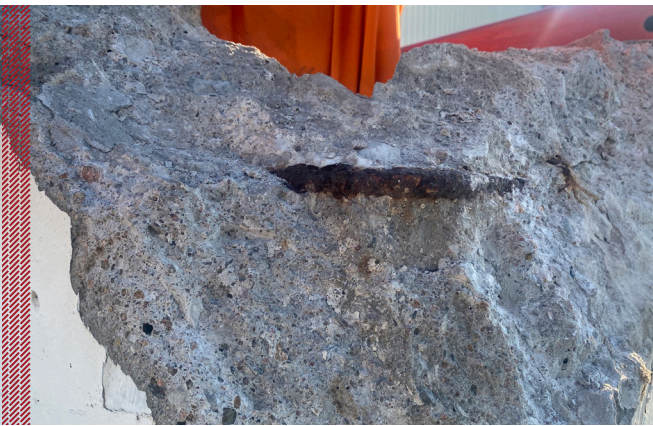
McGill Restoration faced a challenge with the top-level rigging swing platforms. The platforms were a major undertaking as they require significant planning for weather considerations. The work was completed during the fall season when weather events are generally milder. Low chances of major precipitation and wind events prevented delays and allowed the team to work diligently. Saturdays were the only exception as college football season takes over the town but every other weekday was

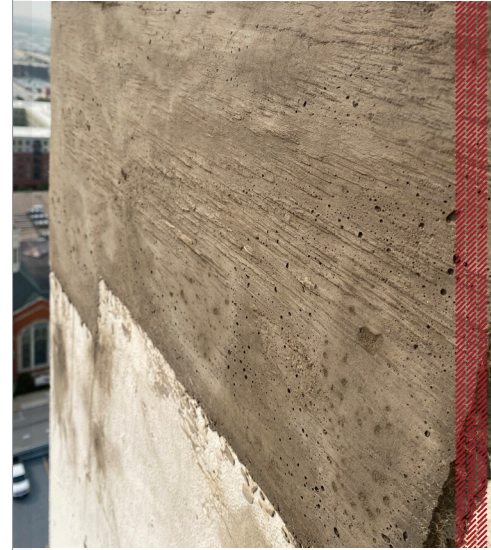
Glass-to-metal window joints are also called glazing joints and urethane is not acceptable for sealing glass. Silicone was the ideal application here while urethane was the most durable bond for the concrete joints. The team diligently sealed every joint on each floor with the proper chemical bond.

The varying types of joints called for multiple sealant types used on each floor. Alternating between sealants called for special attention to cleaning the application guns and to ensuring the proper material was used on each joint.

- ✓ Urethane for concrete-to-concrete joints
- ✓ Urethane for metal-to-concrete joints
- ✓ Silicone for glass-to-metal joints

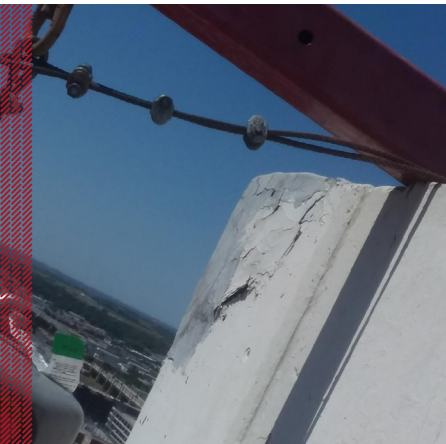
Exterior, above-ground repairs require extensive outdoor rigging, at major costs. While McGill Restoration was tasked with replacing joint sealants, the crew took advantage of the exterior position to inspect the building for additional damage. Damage to fins was discovered as a result of a lightning strike. The damage would have eventually caused leaking and further deterioration but the team repaired the area, saving the client \$40,000 in future rigging costs.

Although not within the planned scope of work, the additional repairs were completed because the McGill Restoration team is dedicated to the success of the structure and stakeholders.
