Nucor Facility Steel and Concrete Restored in 18 Days

McGill Restoration ran double shifts to restore structural integrity to steel beams at the Nucor Pickle House Facility to ensure work was completed during the plant's scheduled seasonal shutdown. Additionally, the team replaced concrete sub-pit beneath acid bath stations. The job required quick turnaround while working with challenging space constraints throughout the narrow facility.

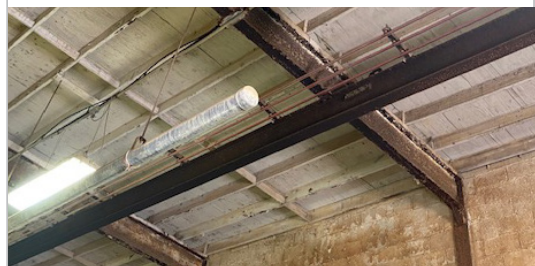
Years of vaporized acid and chemical exposure to overhead structural beams caused protective coating failure and corrosion—to the point of section loss—to the steel. The structural integrity was threatened and required complete cleaning, installation of supplemental steel to restore stability, and application of a robust chemical-resistant coating to deter future chemical contact.

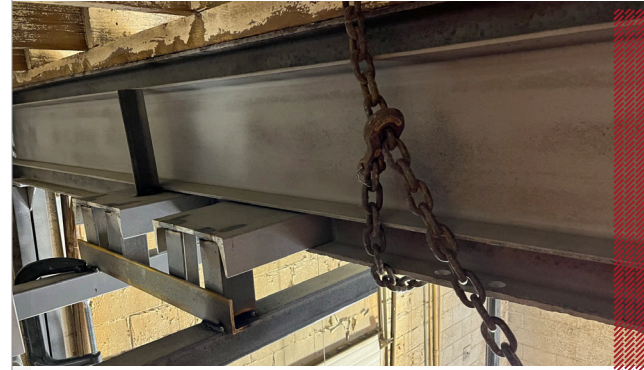
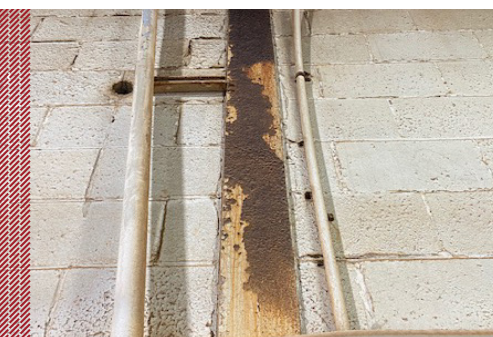
The Nucor plant manager was concerned about meeting the timeline after the first several days of work as spatial challenges had slowed the workflow. McGill Restoration used an adaptable mindset and rather than pressing forward, the team reassessed and tested different ideas until they found a way to hoist beams quickly and effectively. Overcoming this challenge made it possible to complete the job in 18 days, well ahead of the deadline.

The overhead steel beams showed corrosion from years of chemical exposure and they required intensive cleaning ahead of new welding and material installation. The McGill Restoration crew neutralized the beams utilizing a neutralization solution, then sandblasted the entire steel surface area to remove the failed coating, rust and corroded steel to ensure any section loss was addressed, and to start with a fresh slate.

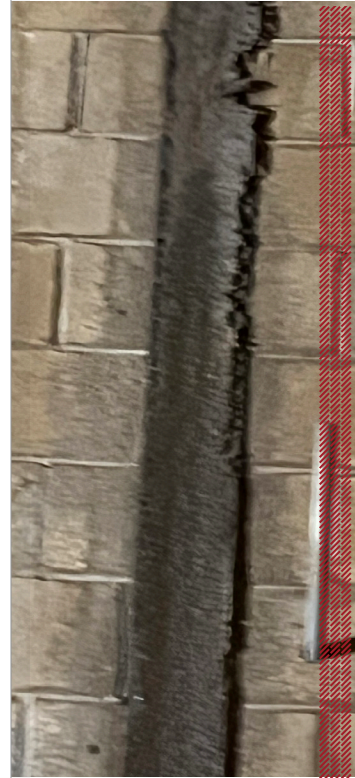
Corroded steel on the beams weakened the overall rigidity and structural abilities of the steel. McGill Restoration responded to the section loss by welding and installing supplemental steel, designed by a structural engineer specializing in steel work. The additional steel returned structural integrity to the beams and the building.

McGill Restoration worked with expert coating manufacturers to select a Novolac epoxy system application to protect all exposed steel. The McGill Restoration coating crews worked rapidly to apply the coating with precision to avoid chemical resistance. The resulting protection has an extended lifespan, limiting the need for near-future work to the pickle house steel.

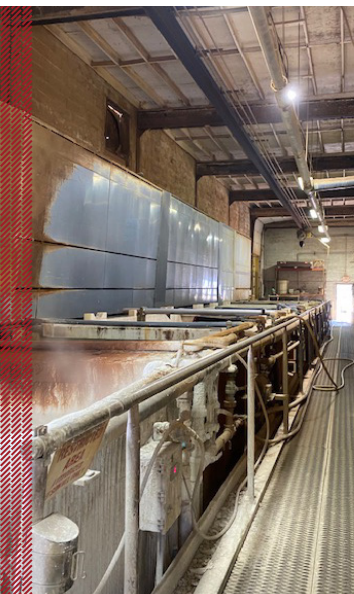
Chemical contact was not limited to overhead steel structures at the Nucor facility. The concrete sub-basin positioned directly below the acid wash stations was designed to catch any overspill, leaks, or runoff chemicals. The constant chemical exposure and contact ate through the uncoated concrete making repairs to the basin extreme and necessary.

The McGill Restoration crews removed and replaced concrete in the 4' x 6' chamber; and following completion of the demo and installation of new concrete in the sub-pit, they added new chemical-resistant, reinforced industrial lining to protect the concrete from future chemical contact and damage.

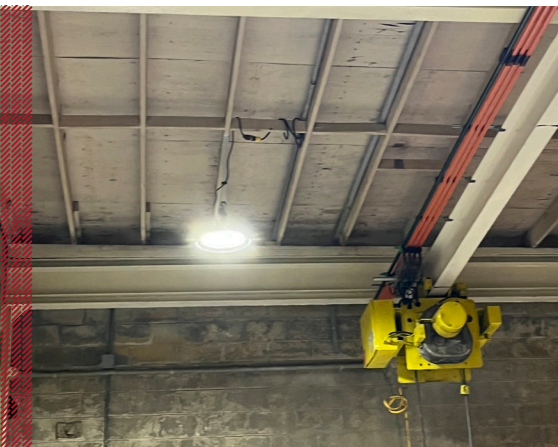
By successfully completing the overhead steel beam restoration and sub-basin concrete replacement, the McGill Restoration team returned structural integrity and chemical resistance throughout the pickle house. All work was completed ahead of schedule, wrapping the job a full four days before the deadline. The Nucor Pickle House returned to operational status knowing their facility was structurally sound and safe to protect workers and continue processing steel for the foreseeable future.
