McGill Restoration Acts as True Partner while Restoring U.S. Bank Building

THE CHALLENGE **Planning Out of State and Across Multiple Budget Cycles**

THE SOLUTION Restoration from the Ground Up

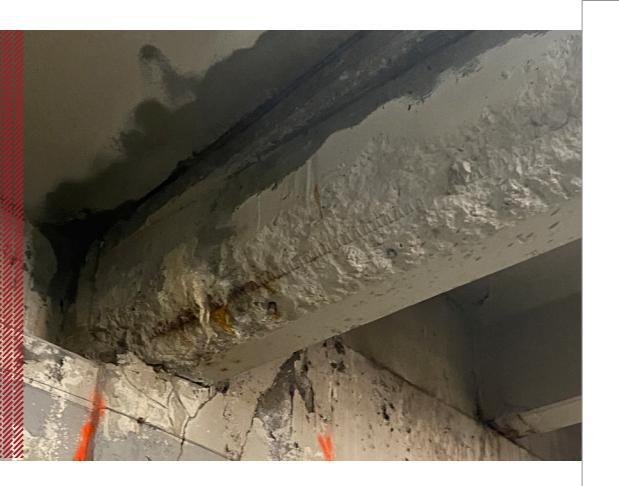
A piece of corroded steel dislodged from the Helena U.S. Bank parking garage, creating cause for concern. After inspecting the structure, it was determined the parking garage waterproofing membrane was compromised and water intrusion was causing serious damage to the concrete and structural steel. Without quick intervention, section loss of steel was imminent and the structure would require costly repairs and rebuilding.

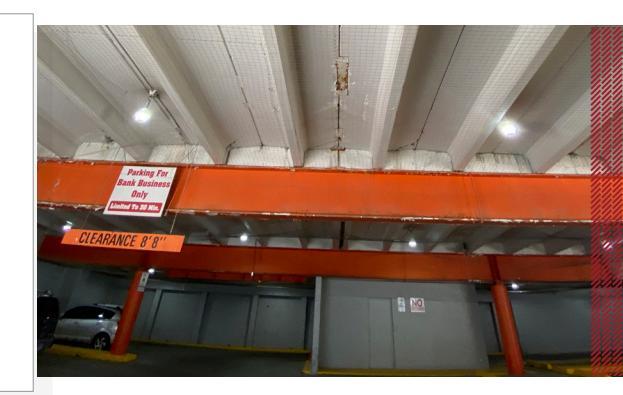
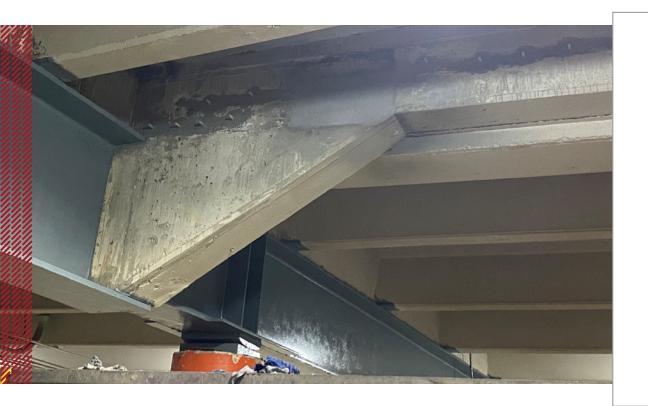
Arguably the biggest threat to this parking garage was corroding steel. Intensive sandblasting (SSPC10) was done to completely remove corroded elements and anything close to section loss was repaired or replaced. Integrity was returned to structural steel and after the sandblasting, a new coating was applied to protect against future corrosion.

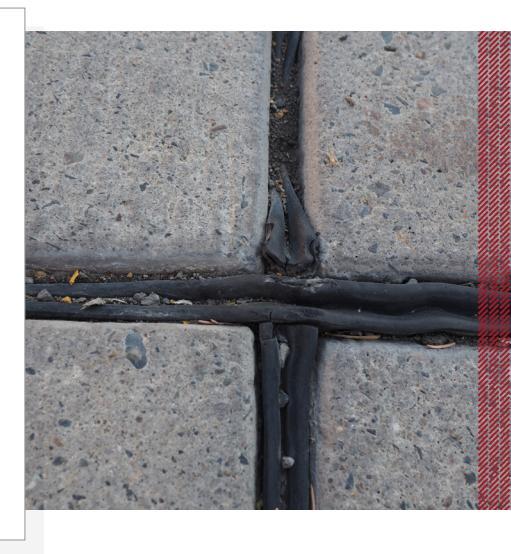
The crew had completed the concrete and steel restoration in the parking garage during winter and they returned in the spring after the threat of winter weather had passed. A penetrating sealer was applied to mitigate water entry until the full top deck would be replaced in the 2023 phase of work.
